WASHINGTON, D.C. SOLAR FOR ALL INSPECTIONS

ABSTRACT

In 2019 and Tetra Tech and Green Powered Technology conducted over eighty QA/QC inspections of solar PV installations across Washington, D.C. in support of the Department of Energy and the Environment's (DOEE's) Solar for All program. The program aimed to provide many of the district's residents with the opportunity to obtain the benefits of solar PV through grants to fund the installation of residential, commercial, and community PV systems. Under the program, PV systems were installed on single family homes, multifamily homes, commercial buildings, and parking canopies. Eleven different grantees oversaw the installation of the systems, each with different installers and equipment.

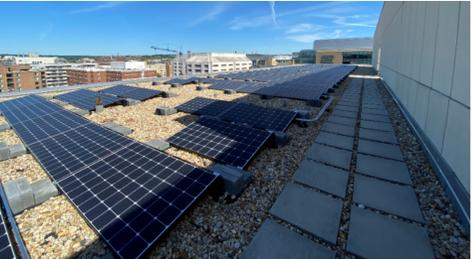
Monitoring

- Connectivity issues with the monitoring system (rare)
- Residents did not have access to online monitoring (rare)

System Design

- Shading (rare)

System Design

- Update drawings to reflect actual installation
- Monitor systems with unavoidable low module tilt for ponding and soiling

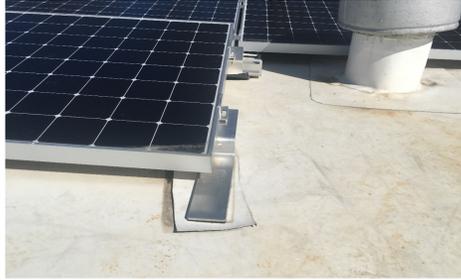
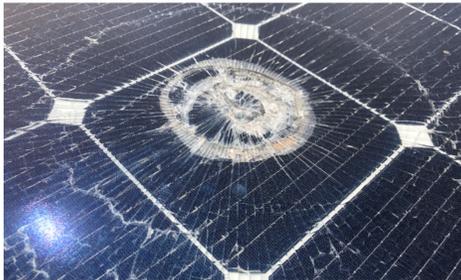
Electrical

- Overcurrent protection device sizing inconsistent with drawings
- Incorrect sizing may be a safety hazard

Modules

- Cracked modules (rare)
- Will result in performance losses

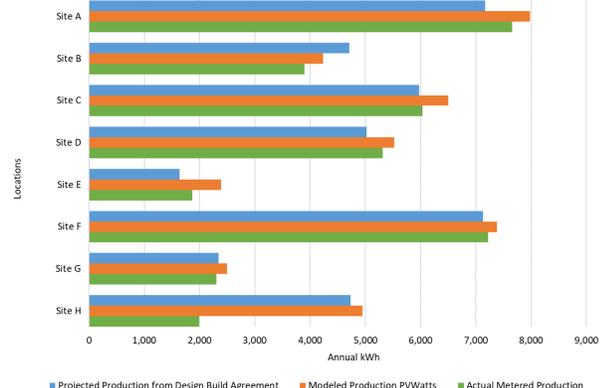
Modeling suggests production targets will be met and DC income-qualified customers will receive the intended benefits

- Modeled production compared to designed production ranges from 79% to 138%
- Actual production compared to designed production ranges from 81% to 127%
- Actual production compared to modeled production ranges from 81% to 100%

Lower production was due to:

- Changes from design to actual installation
- Shading issues
- Inverter issues or broken modules
- Variabilities experienced during initial operation phase

- Designed production was based off of the as-built documentation
- Grant systems were modeled using PVWatts and data collected while on site
- Actual production was from dashboard data provided by each grantee
